Manhole Inspection Summary

Manhole # S33G__027MH

Insp Date: **9/12/08 1:41 PM**

Location Address: **11 Cider Al**

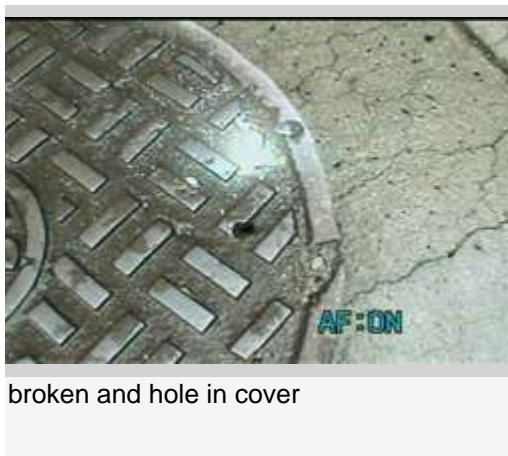
Defect 7

Condition: **Broken**

broken and hole in cover

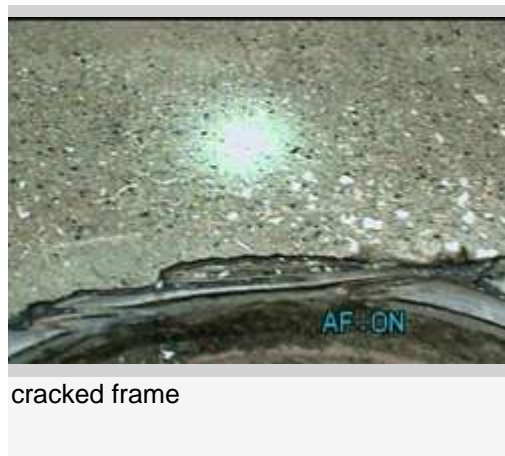
Defect 5

Frame Offset: **0** (in.) Condition: ☐ Sound ☒ **Cracked** ☐ Leaks

cracked frame

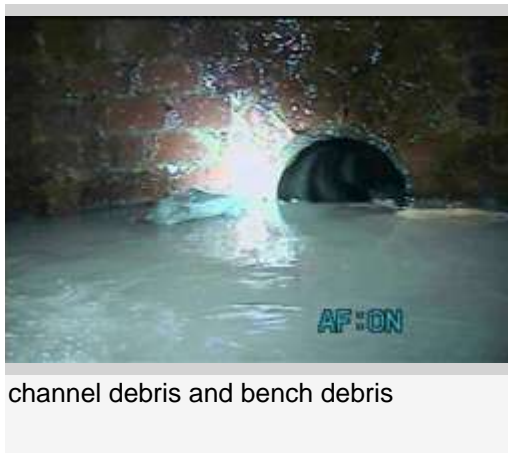
Defect 6

Condition: ☐ Sound ☐ Cracked ☐ Root Intrusion ☐ Deteriorated ☐ Leaks ☒ **Debris**

channel debris and bench debris

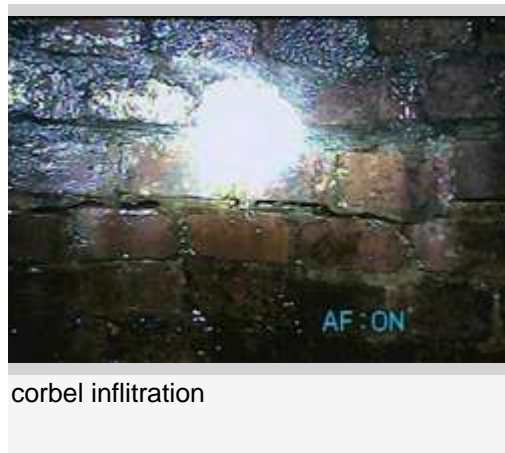
Defect 4

Infiltration: ☐ None ☐ Joint ☐ Cracks ☐ Mortar ☐ Roots ☒ **Wall**

corbel infiltration

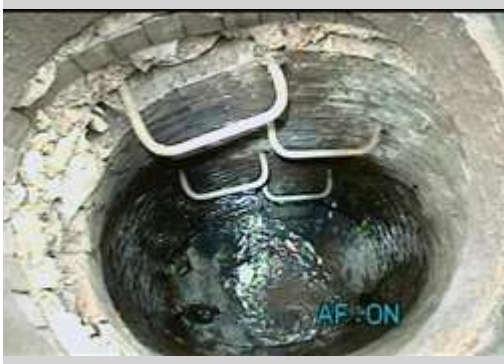
Defect 3

Steps Count: **6** Missing: **0** ☒ **Corroded**

steps

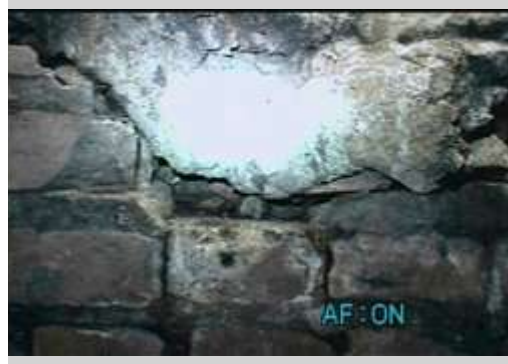
Defect 2

Condition: ☐ Sound ☐ Cracked ☐ Root Intrusion ☐ Loose Brick ☒ **Deteriorated**

crack in corbel and deteriorated

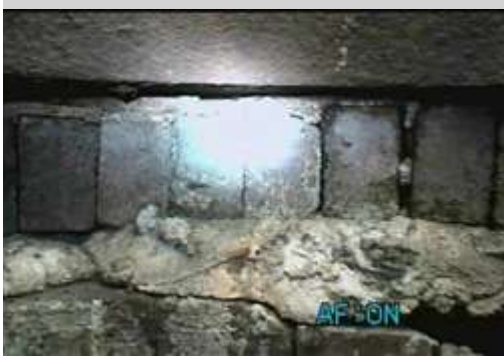
Defect 1

Condition: ☐ Sound ☒ **Cracked** ☐ Root Intrusion ☐ Loose Brick ☐ Deteriorated

chimney cracked, frame adjustment
